Manhole Inspection Summary

Manhole # S07WW_001MH

Insp Date: **1/12/09 11:01 AM**

Location Address: **GRANTLEY RD ALLEY**

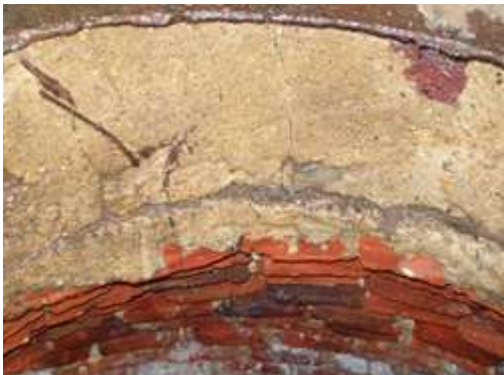
FRAME ADJUSTMENT

Chimney / Frame Adjustment ☒ Exists Material: **Brick and Concrete** ☐ Parged Height: **6** (in.)

Condition: ☐ Sound ☒ **Cracked** ☐ Root Intrusion ☐ Loose Brick ☐ Deteriorated

CRACKED ADJUSTMENT

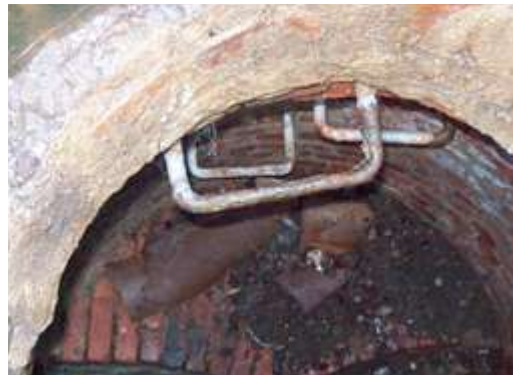
Defect 3

Steps Count: **3** Missing: **0** ☒ **Corroded**

CORRODED STEPS, DEBRIS ON BENCH

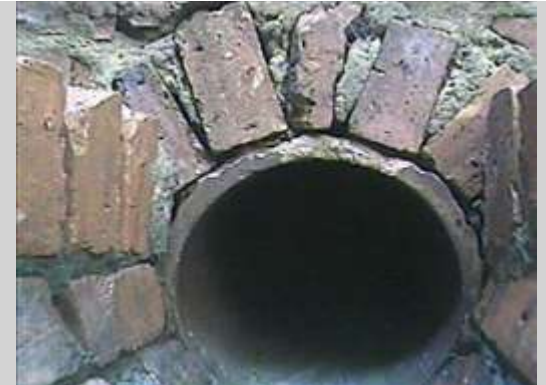
12 O'Clock Outflow

8 in. Circular Gravity Sewer
Pipe Out @ 12 O'Clock

Pipe Height: (in.) Direct
Pipe Material: **Clay** ☐ Pipe Lined
Invert Depth: **6.51** (ft.) Flow Characteristics: **Slow**
Deposits: ☒ None ☐ Mud ☐ Sludge ☐ Debris ☐ Grease
Silt Depth: (in.) Deposits Extent:
Infiltration: **None** Pipe Seal Cond: **Broken**

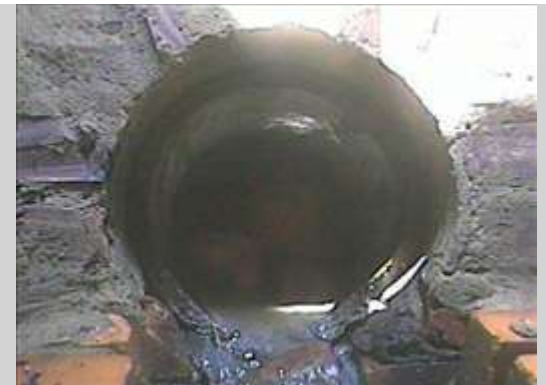
3 O'Clock Inflow

8 in. Circular Gravity Sewer
Pipe In @ 3 O'Clock

Pipe Height: (in.) Direct
Pipe Material: **Clay** ☐ Pipe Lined
Invert Depth: **5.92** (ft.) Flow Characteristics: **Slow**
Deposits: ☒ None ☐ Mud ☐ Sludge ☐ Debris ☐ Grease
Silt Depth: (in.) Deposits Extent:
Infiltration: **None** Pipe Seal Cond: **Sound**

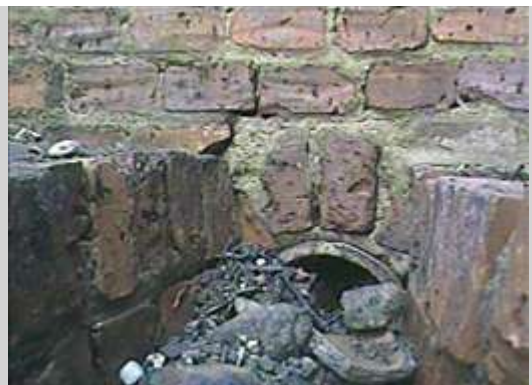
9 O'Clock Inflow

8 in. Circular Gravity Sewer

Pipe In @ 9 O'Clock

Infiltration: **None** Pipe Seal Cond: **Broken**

Connects To: **Stub connection / abandoned**
